MERRIMACK RIVER BASIN  
DORCHESTER, NEW HAMPSHIRE

**BAKER FLOODWATER RESERVOIR  
SITE 8**

**NH 00178**

**PHASE I INSPECTION REPORT  
NATIONAL DAM INSPECTION PROGRAM**

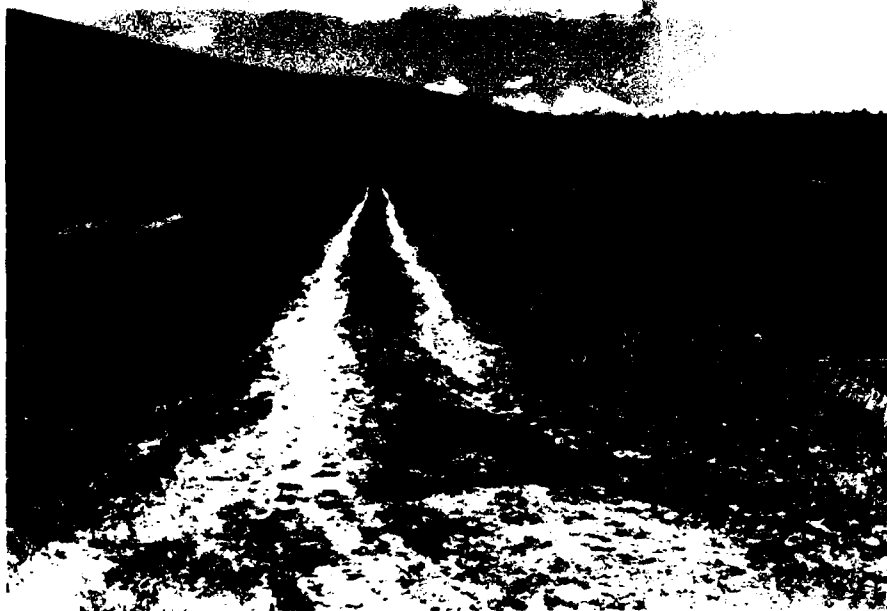
The crest of dam is 14 feet wide and is grass covered with grass with the exception of an unpaved roadway which is shown in Photo No. 5. No significant misalignment of the crest was observed.

PHOTO NO. 5 - View of dam crest from right abutment.

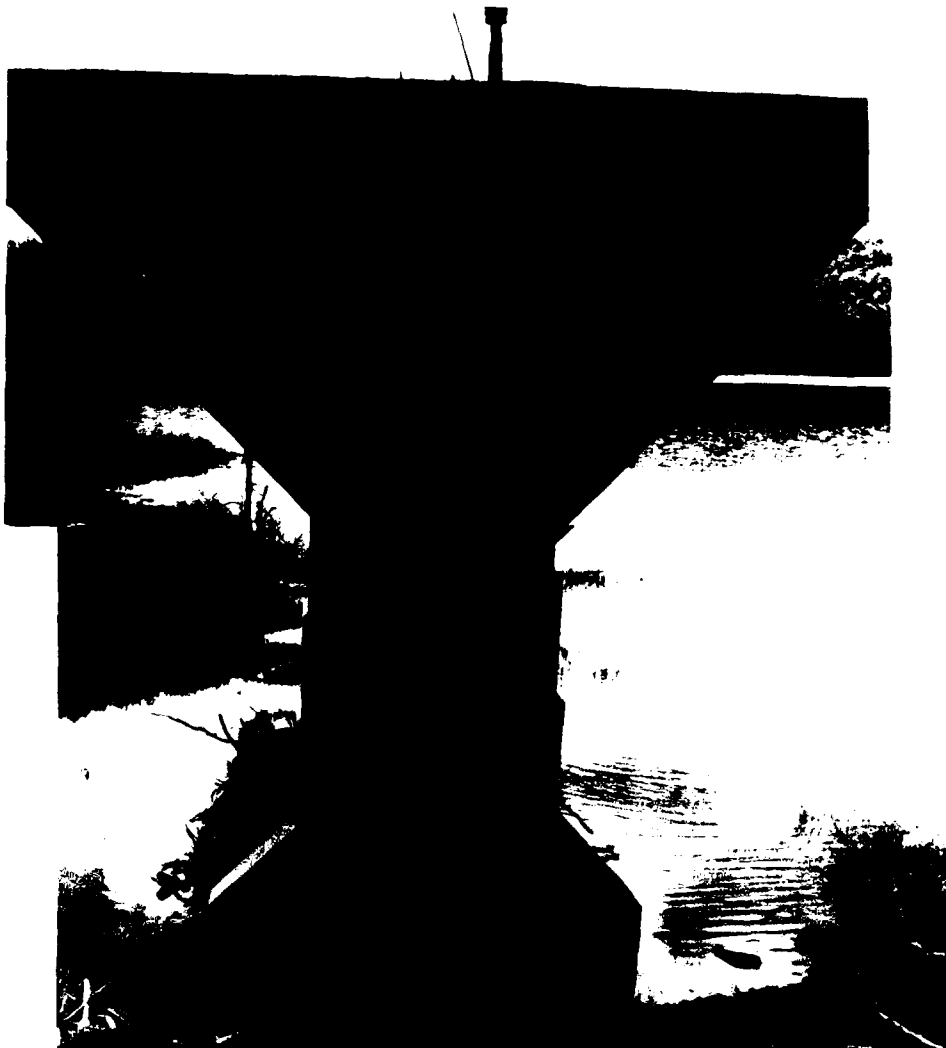
(a) Some surface deterioration in the form of staining, cracking and scaling of the concrete on the riser portion of the principal spillway.

Water staining, cracks and loss of mortar in concrete surface. Photo No. 7

PHOTO NO. 7 - View of riser and covered top high stage inlet from dam.

(b) Repair the deteriorating surface of the concrete on the riser structure.

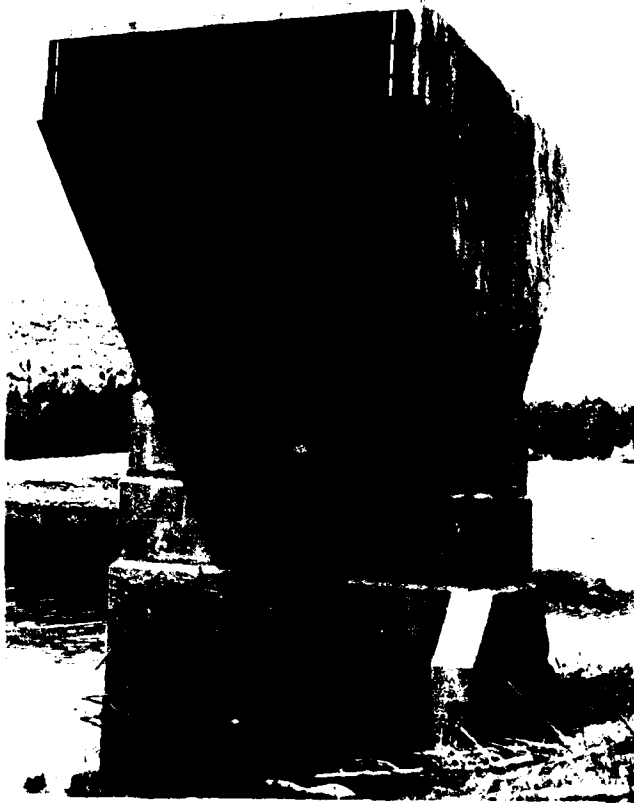
The trash racks at the low and high flow control stages consist of a standard shape angles and grating. Both trash rack assemblies are in good condition. No rust or peeling of the protective coating was noted. The low stage trash rack structure is filled with debris.

PHOTO NO. 10 - View of  
high stage and low  
stage trash racks on  
right side of prin-  
cipal spillway.

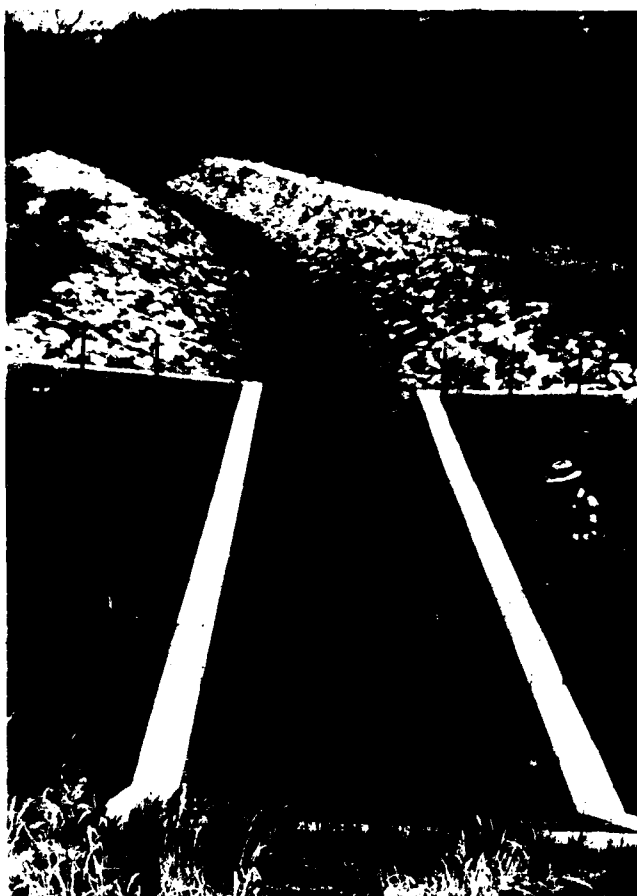
The discharge channel below the stilling basin extends for a distance of 350 feet downstream of the outlet works (Photo No. 12). The channel is lined with rock riprap and is in excellent condition.

Piezometers were installed behind each wingwall in 1973 as part of the investigation to remedy the wall movement. The study was conducted by professional engineers from the New Hampshire State SCS office in conjunction with professional engineers from the regional SCS office in Bromall, Pennsylvania. The above noted modifications are based on recommendations from this study. The report entitled "Report on Investigation of Structural Deficiency - Site 8, Baker River Watershed - Grafton County, New Hampshire," dated March 1976 is available on request from the SCS. The piezometer pipes may be seen in Photo No. 12.

PHOTO NO. 12 - View of  
a portion of SAF  
stilling basin and  
outlet channel.

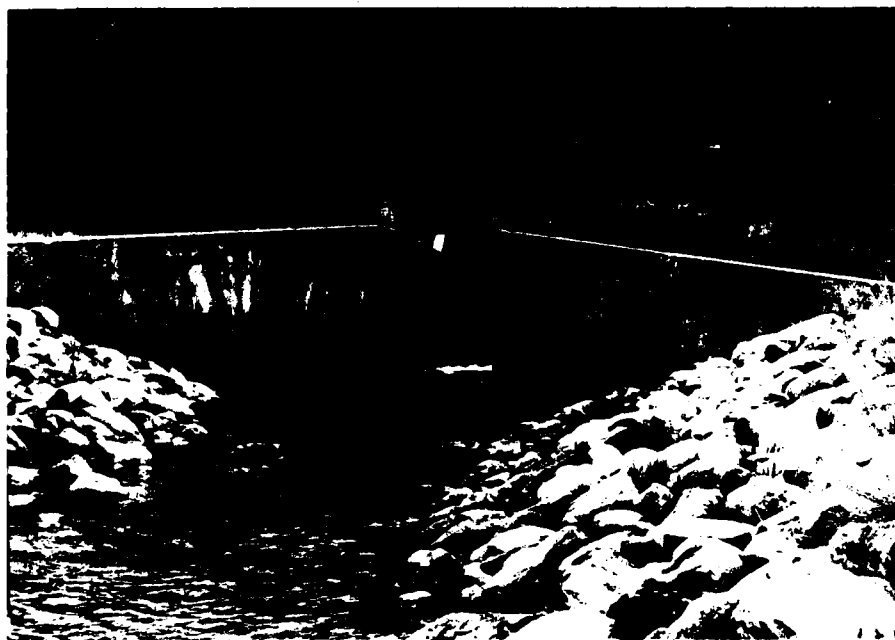
d. Post Construction Changes. The outlet pipes of the foundation drainage system originally passed immediately behind the outlet works training walls and exited through the wingwalls, as shown in Photo No. 13. In 1977, in order to provide better drainage around the SAF outlet, the location of the drain pipes was moved away from the outlet works and carried below the structure to outlet into the discharge channel. The new drain pipe

PHOTO NO. 13 - View of outlet works.
